A Method and Device for Health Monitoring of Glass Armor

By Thomas J. Meitzler^{*}, Thomas Reynolds⁺ and Samuel Ebenstein⁺

ABSTRACT

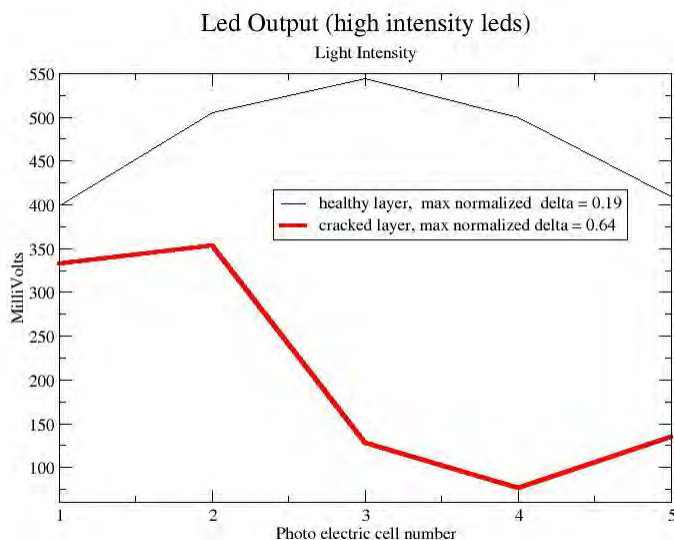
Figure 2 LED output per layer of the glass cube

Figure 2 shows the change in light intensity in moving from each photo transistor to the next one. Based on the sharp change in photo intensity in layer 2 as compared with layer 1, we

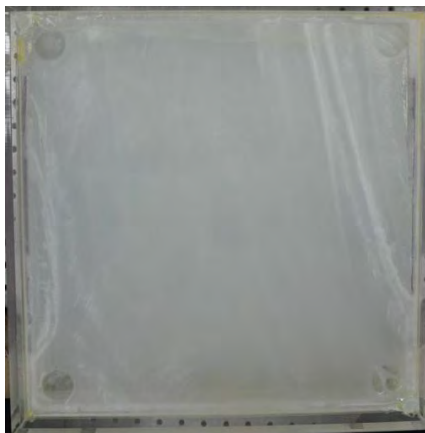
Figure 3 a Top View of a healthy Armor Sample

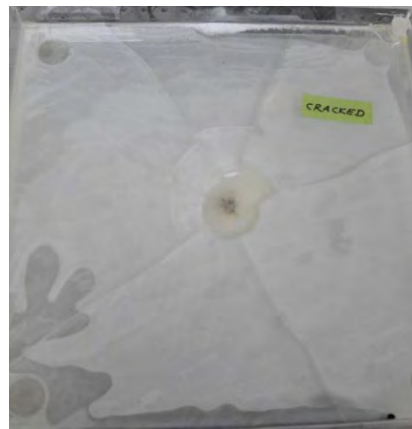
3b Top View of a damaged Armor Sample

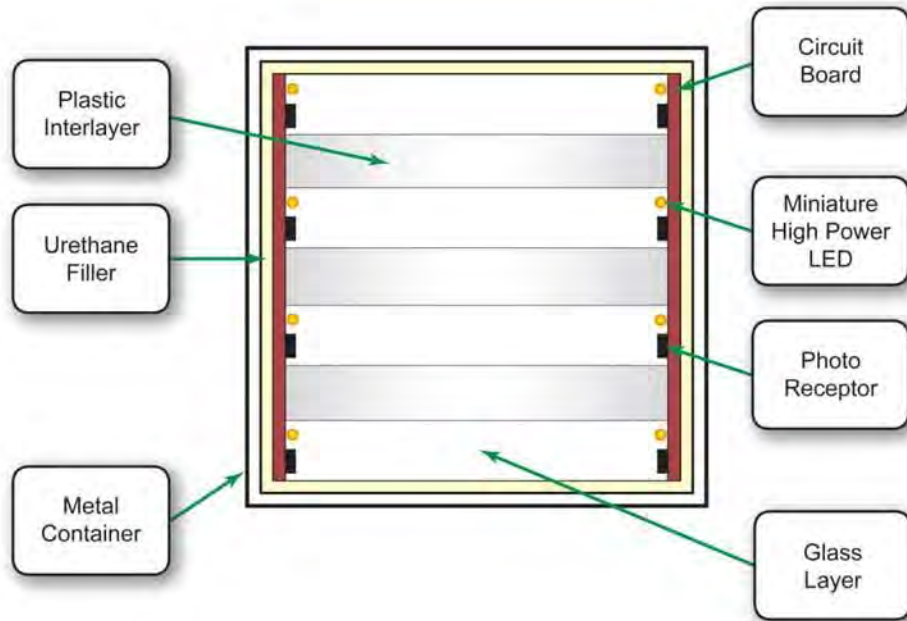
Figure 4 Hardware configuration of the inspection system

As shown in Figure 4 the cube has 4 glass layers, and these glass layers are separated from each other by plastic inner layers. The entire cube is encased in a plastic box. A Urethane filler is used to prevent the glass layers from movement in the box. The plastic container is then encased in a steel container. The circuit board needs to fit in the 6 mm space between the glass plates and the plastic box.

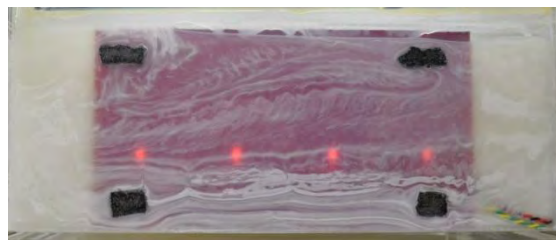
Figure 5 Image of the circuit board (side view)

Figure 5 shows a side view of the circuit board which is only a few millimeters thick and has been inserted inside the cube. Four LED's in one layer are lit, and they are clearly visible in this view.

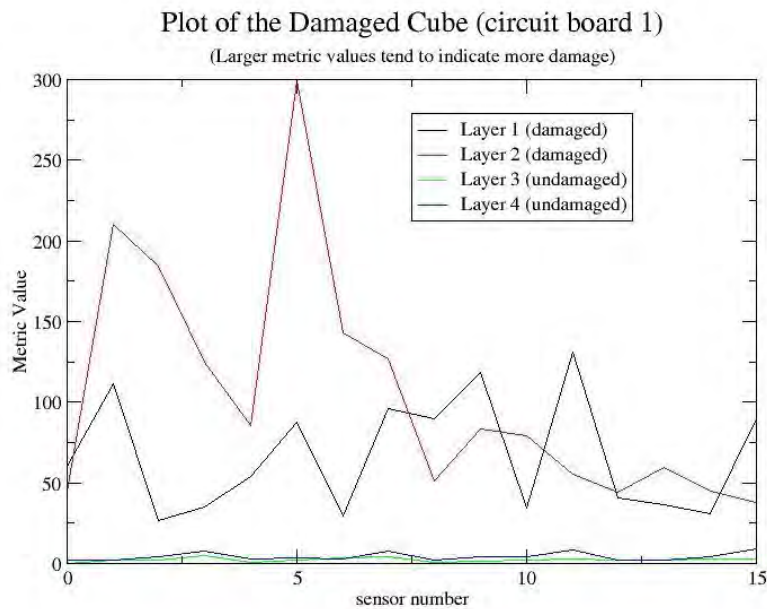
Figure 6 Plot of the Damaged Cube

Figure 6 shows the metric values for the damaged cube. Since there are 4 LED's per layer and 4 photo transistors we have a total of 16 readings per layer. Layers 1 and 2 have significantly high readings than layers 3 and 4. This is due to the fact that the cube was hit with a ballistic round which penetrated the top two layers, but had little effect on the bottom two layers. Figure 7 looks somewhat similar to Figure 6 in terms of variability, but there is more than two orders of magnitude difference in the scales on the two graphs. (Figure 6 has a scale of 0 300, while Figure 7 has a scale of 0 to 2). A comparison of Figures 7 and 8 shows that the values from circuit board 1 and 2 are quite similar. The scores from circuit board 1 and 2 are not identical because of slight differences in the positions of the LED's and phototransistors on the two boards.

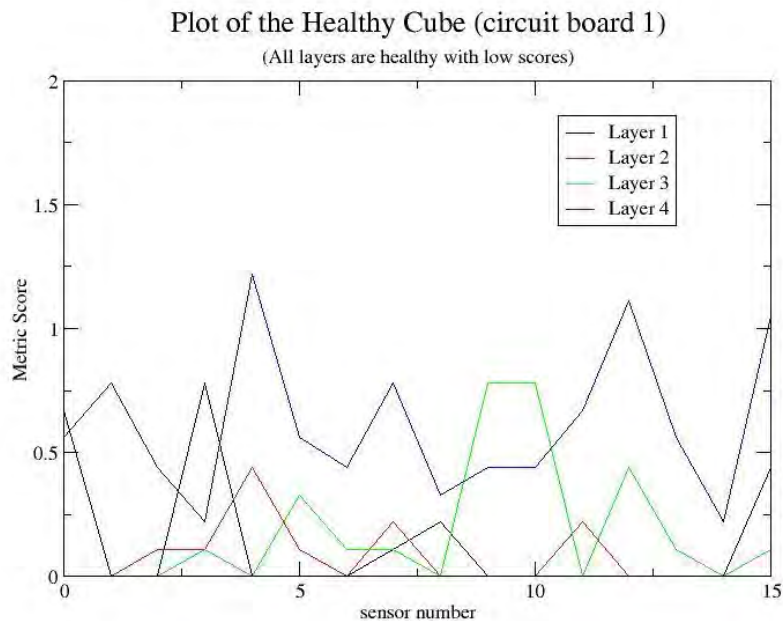
Figure 7 Plot of the Healthy Cube (circuit board 1)

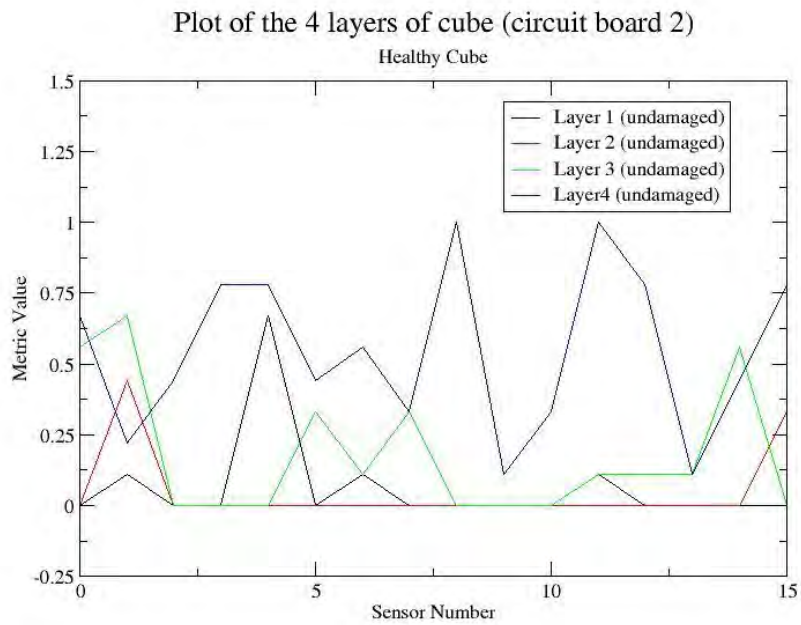
Figure 8 Plot of the Healthy Cube (circuit board 2)

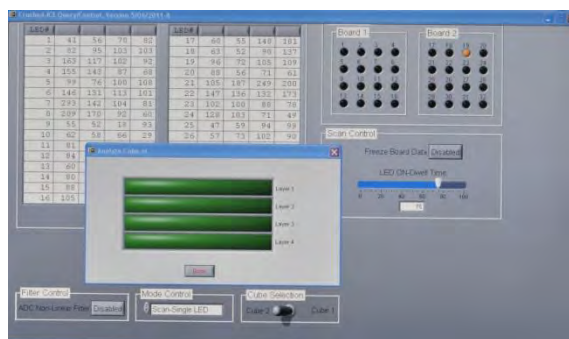
Figure 10a System Output from a Healthy Armor Cube

Figure 9 shows that the system is quite repeatable for the healthy cube. It also shows that the damage to the upper two layers of the damaged cube has caused some change in the values of the lower two layers that weren't damaged. Figures 10a and 10 b show the difference between a healthy and a damaged cube. In Figure 10a all four layers of the cube are green which indicates that the entire cube is healthy. In Figure 10b the top two layers are red which indicates they have been damaged. The bottom two layers are green so they are considered healthy.

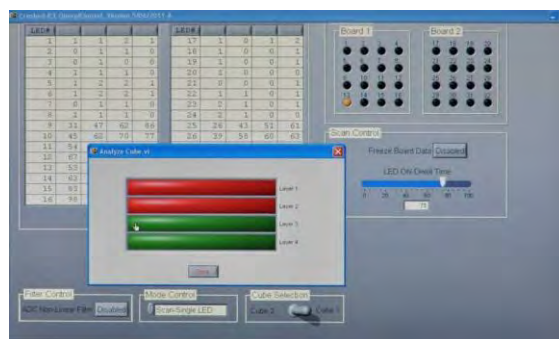
Figure 10b System Output from a Damaged Armor Cube
